Super Salvage, Inc.
Industrial Stormwater Inspection Report

Appendix B

Photograph Log and Photographs

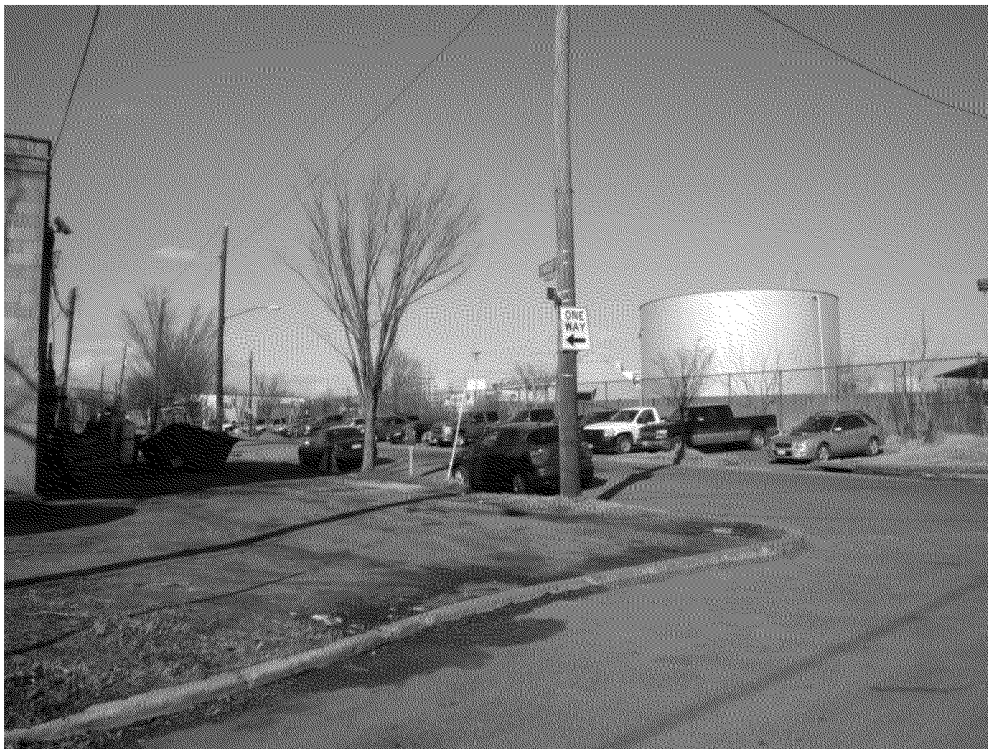
Photograph 82. Staining at the intersection of First Street SW and S Street SW.

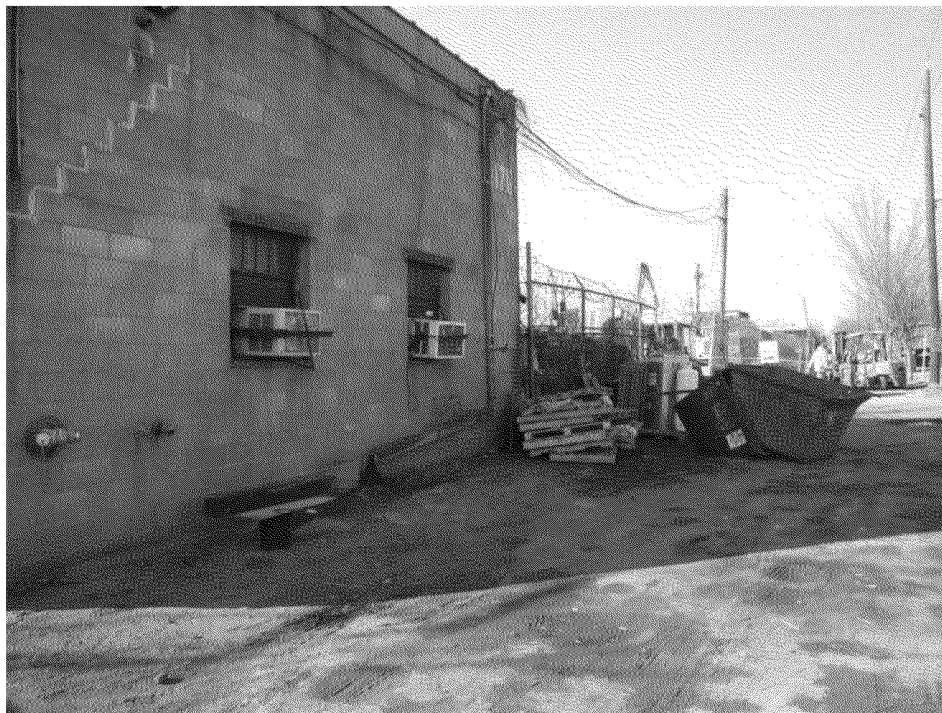
Photograph 83. View of the gutters and roof drains and the stained exterior of the facility near the corner of First Street SW and S Street SW.

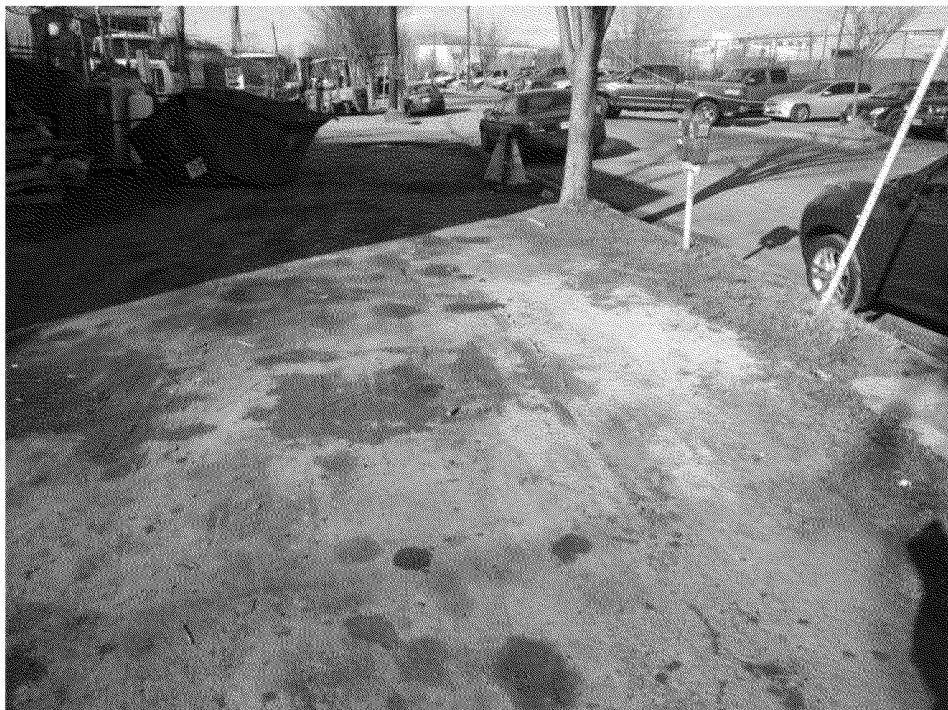
Photograph 84. Stains on the sidewalk adjacent to the site near the corner of First Street SW and S Street SW.
